Smoke and Dye Testing Summary

High Level Sewershed

Test ID	Test Type	Date Inspected	Company / Super.	Blower MH	Ground Condition	Notification Made?	Total Length
S1028-061	Smoke	9/3/2008	ADS/TM	S09EE1011MH	Dry	Yes	1,638.67

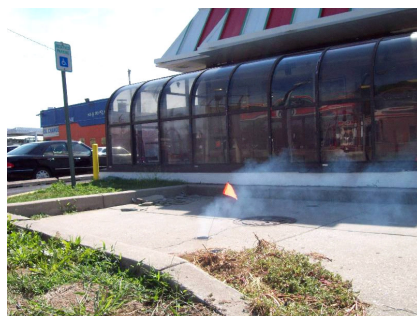
Picture \S1028-061-OB01-P01.jpg

Comments Smoke from cleanout in front parking lot. 3319 Cold Spring Lane

Comments Front of building, 3319 Cold Spring Lane

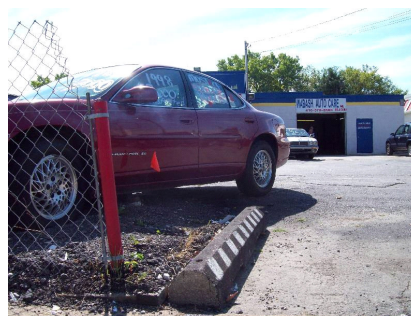
Picture \S1028-061-OB02-P01.jpg

Comments Smoke from cleanout in front lot of building. 3315 Cold Spring Lane

Comments Front of building, 3315 Cold Spring Lane
